Geological Solutions for Providing a Scientific Basis for Differing Site Condition Claims

Charles Merguerian, Duke Geological Laboratory, 55 Spongia Road, Stone Ridge, NY 12484, (845) 687-6386; CharlesM@Dukelabs.com

Abstract

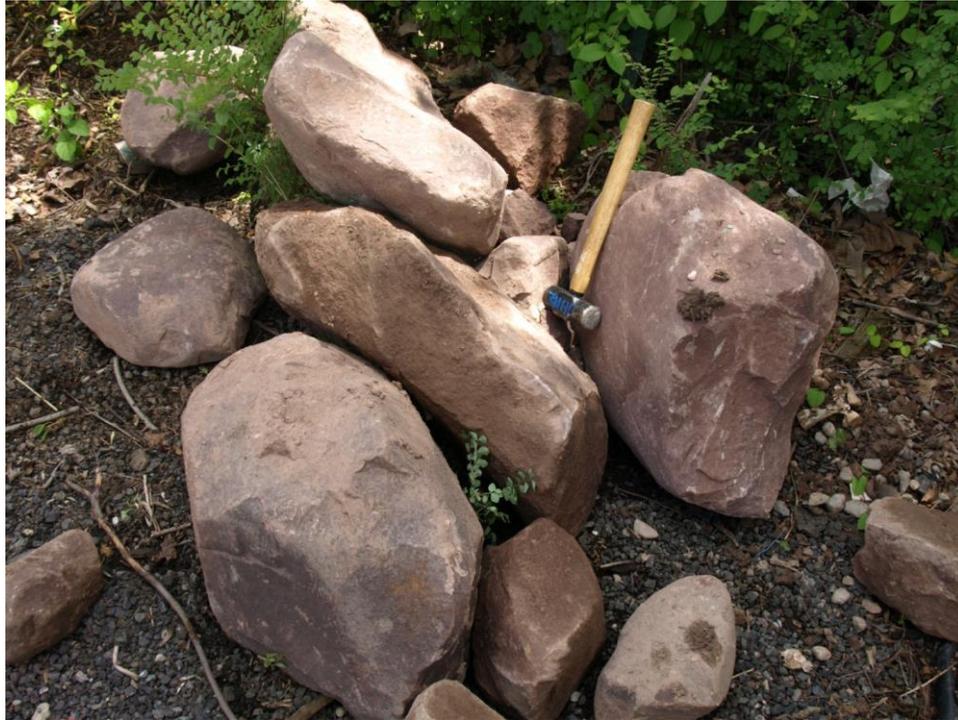
Based on the presence of mineralized joints, sub-angular/tabular shape aspect, and curved scratches, our conclusion was that the boulders were locally harvested (not of glacial origin), introduced from the shaft walls during drilling of fractured ground and dragged about during the drilling or mucking process before they were removed from the base of the shaft. Boulder composition was an identical match with the local Passaic bedrock. They were not Paleozoic quartzite or limestone which had been reported as indigenous boulders from within the Passaic

Formation by other field workers. Indeed, these observations forced the conclusion that the boulders were introduced from the shaft walls during construction drilling.

Figure 3 – View of subangular boulders and cobbles of Passaic Formation siltstone and sandstone mucked from base of Shaft #23. Note the tabular aspect of the boulders, a relic of original bedding, and the incipient polishing by mechanical means. Hammer is 38 cm (15”) in length. (Dukelabs digital image taken 14 June 2013.)

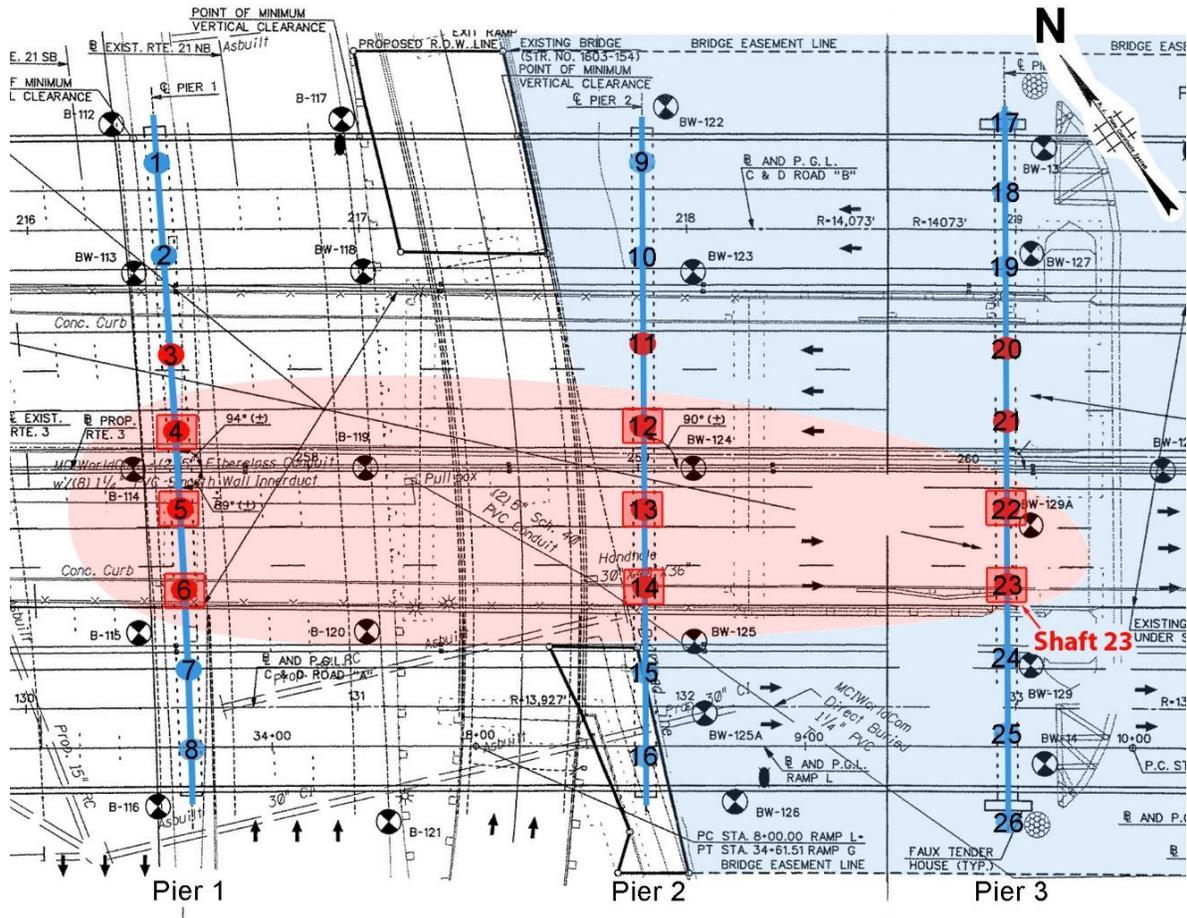
Figure 4 – Site map showing the eight problem shafts (4, 5, 6, 12, 13, 14, 22 and 23 – boxed and numbered red circles) drilled in Piers 1, 2 and 3 and how they define a NW- to SE-trending zone of similar ground effects (pink ellipse) both on land (uncolored) and within the river (blue).

Note that on Figures 4 and 8 that the eight DSC caissons (Shafts #4, 5, 6, 12, 13, 14, 22 and 23) are not evenly distributed throughout the jobsite but are spatially oriented with a NW to SE alignment parallel to the NW-SE faults. This is additional evidence for a DSC with 17.8% of the 45 shafts affected as the extension of mapped faults conforms to the pink ellipse of affected shafts shown in Figure 8. Thus, there appears to be geological continuity of cause and effect.

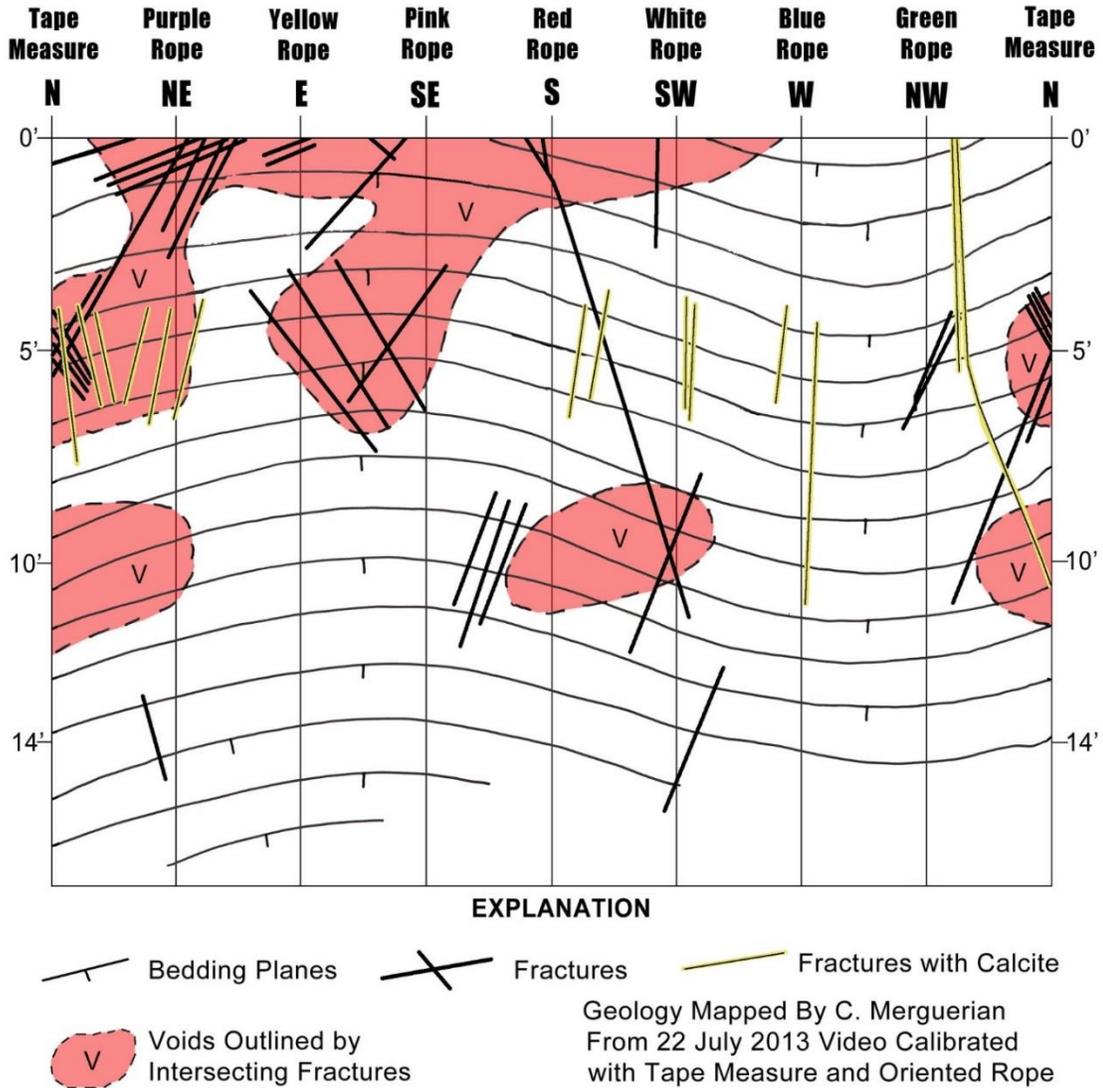
CIRCUMFERENTIAL MAP - SHAFT 23 ROCK SOCKET PASSAIC RIVER BRIDGE

Figure 6 – Circumferential geological map of bridge Shaft #23 rock socket of 90” (7.5’) diameter showing orientation of inclined bedding planes (thin black lines with tick marks), intersecting steep to gentle fractures (thick black lines) and open voids where blocks fell out of socket sidewall (v - pink areas). Also shown are mineralized fractures in yellow and black. Drawn with no vertical exaggeration. Compass directions are magnetic.

The steep dislocations fall into three major geometric classes. The most prominent and through-going mapped feature is a fissure that extends through the rock socket center and downward over 10' in extent with a $N35^\circ E$ strike and $75^\circ NW$ dip (center of image in Figure 7). Also mapped were at least five (5) less extensive fractures that parallel this main fissure as is common in fault zones. There is also a younger set of shorter, closely spaced mineralized conjugate fractures with a $N25^\circ E$ strike and $80^\circ SE$ dip fanning through vertical to dips of $80^\circ NW$. These discontinuities overlap and seem to crosscut the major NE-trending fracture set.

Figure 6 shows that four major open voids exist in the drilled rock socket of Shaft #23 from the base of the casing to about 8' depth, then again at about 10' depth. The voids are 3' to 8' in extent, extend a few feet deep into the sidewall and are concentrated up-dip in the eastern half-perimeter of the rock socket as would be expected if the blocks initially slid along bedding planes into the rock socket. Many of the open voids were found to terminate against steep planar fracture surfaces suggesting emphatic fault control of blocks that fell into the shaft along the regional dip of bedding planes. Figures 6 and 7 clearly document the relationship between areas of multiply fractured bedrock and associated angular voids detected in the subaqueous videos.

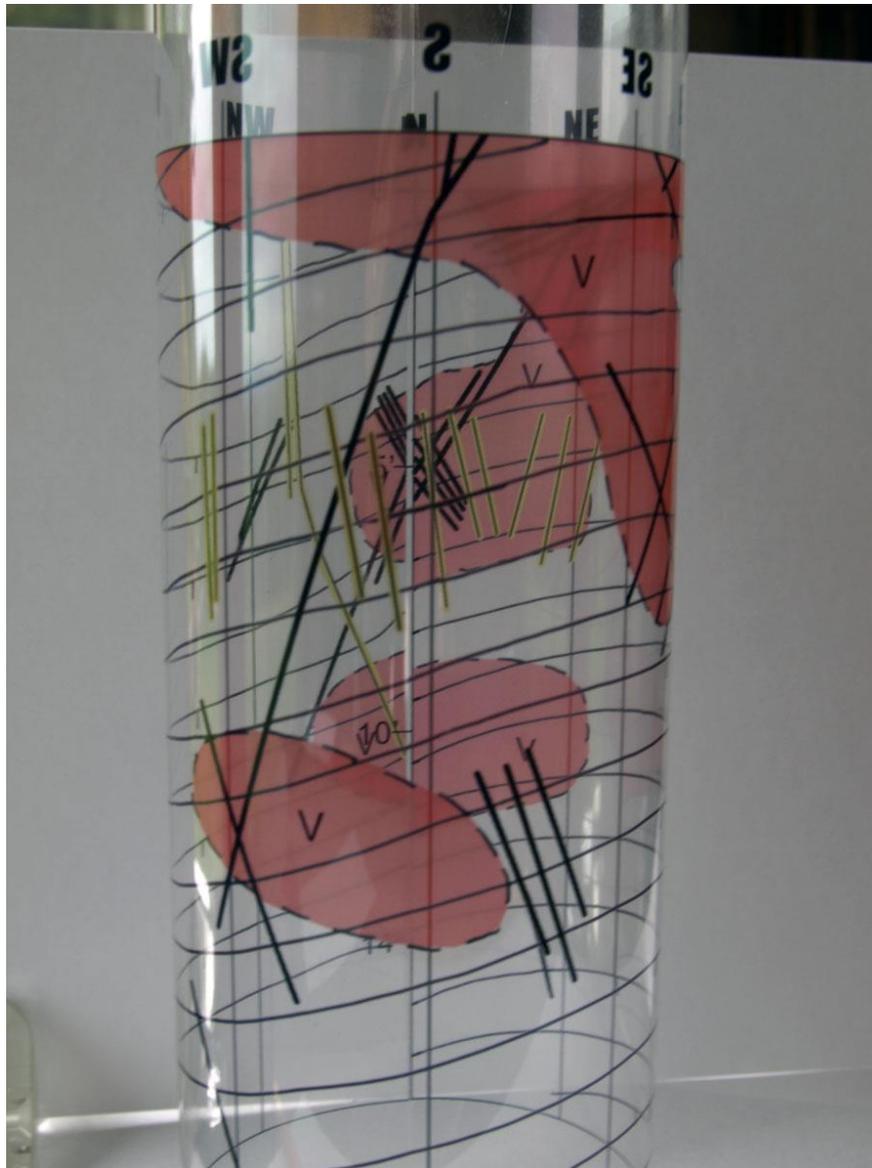
Figure 7 – Northward view of Shaft #23 rock socket acetate map of Figure 6 curled into a cylinder showing the relationship of bedding planes ($\sim 14^\circ$ NW dip [thin closely spaced lines]), NNE-, NE- and NW-trending fractures (steep, black lines), and voids (pinkish areas - v). Note that some of the steeper, NNE-trending fractures (outlined in yellow) are mineralized by calcite or whitish zeolite, common minerals found within faults and joints in the Newarkian strata and also observed in the boulders shown in Figure 3, above. Not obvious are gently inclined ($\sim 14^\circ$) fractures that parallel bedding near the top of the map at the base of casing.

The steeper conjugate fractures sometimes show mineralization with calcite or a whitish zeolite mineral as indicated by yellow and black markings in Figures 6 and 7. A third prominent set of steep fractures strike N40°W and dip 70° toward the NE. A fourth set of dislocations occur near the top of rock. These are closely spaced, shallow in dip and cut bedding at a very low angle. These are simple bedding plane joints that trend NE and dip very gently (~14°) NW.

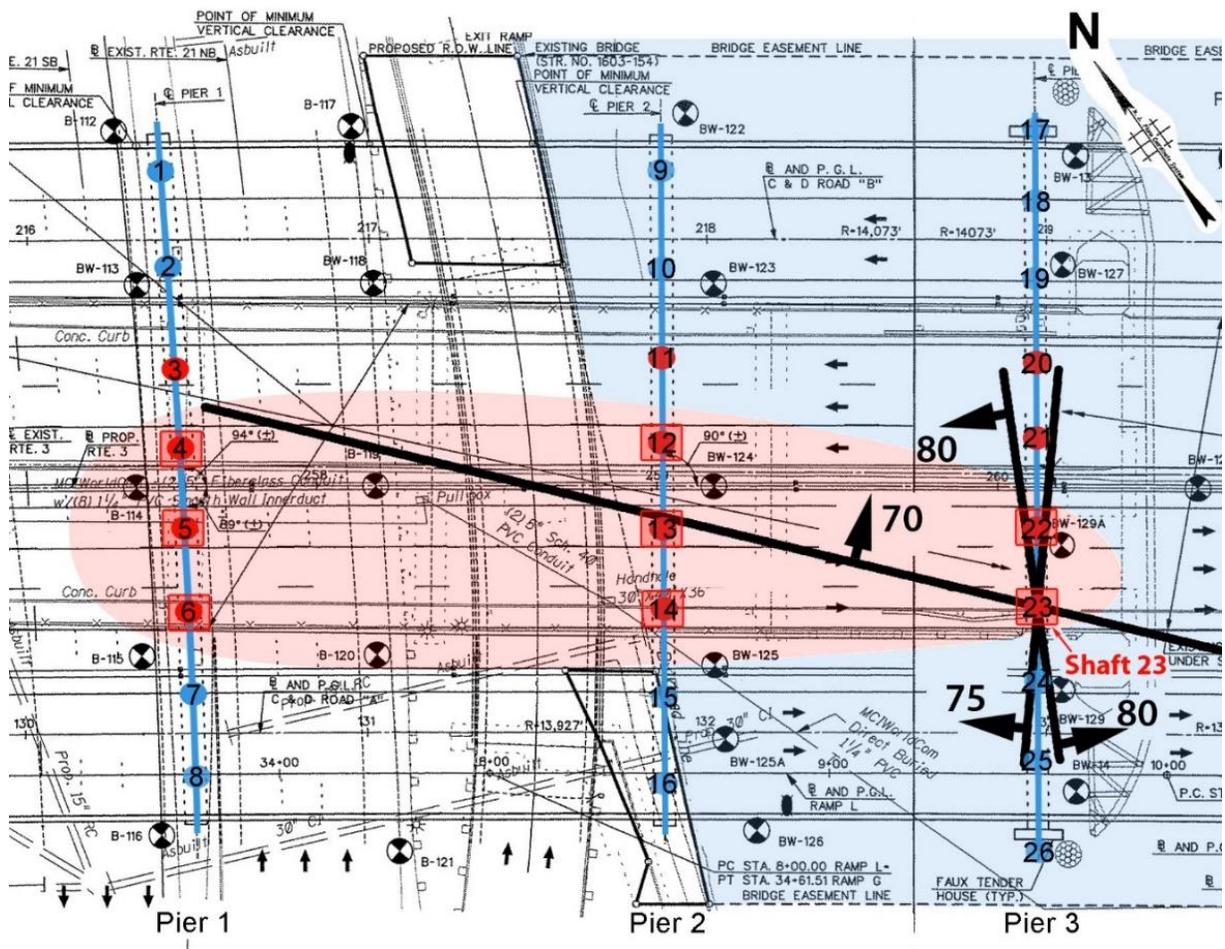
Multiple fault and fracture convergence as found at the Shaft #23 site are unusual geometric subsurface conditions. Convergent high-angle fractures superimposed on gently inclined bedding plane joints created blocky ground and the excavation led to voids because of fallout from the sidewalls. The Shaft #23 site showed changed site conditions but the projection of fracture trends to other shaft sites explained the formidable extent of bad ground conditions extending out from the Shaft #23 zone of fracture convergence and intersection.

Figure 8 – Plan view of DSC claim area (pink ellipse) that includes the eight problem shafts encountered during Piers 1, 2 and 3 drilling of the bridge. The faults and related joints mapped from Shaft #23 are plotted to show their crosscutting relationships and geometric structural control on the associated problem shafts of the DSC claim. Note that the three steep fracture systems shown in Figures 6 and 7 (N40°W strike, 70°NE dip; N35°E strike, 75°NW dip and N25°E strike with conjugate dips fanning from 80°NW through vertical to 80°SW). These intersecting fractures extend outward from that zone of convergent intersection and cut gently inclined in-situ bedding planes and sub-parallel shallow joints at Shaft #23. Note that all faults were plotted with respect to True North as the magnetic declination at the site in 2013 was -12° 50' (12° 50'W of True North).

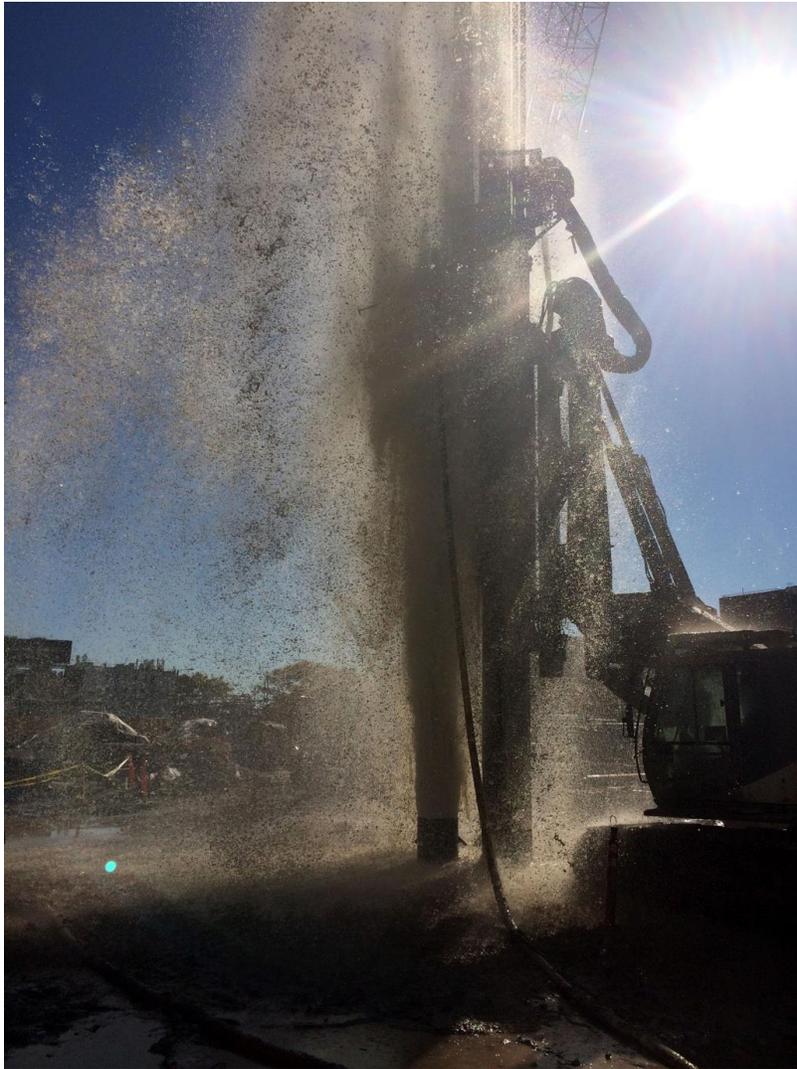
Figure 9 – View of as-built anomalous water + material flow and geysering associated with caisson drilling in November 2015 at a terrestrial caisson/pile drilling job site. (Contractor image.)

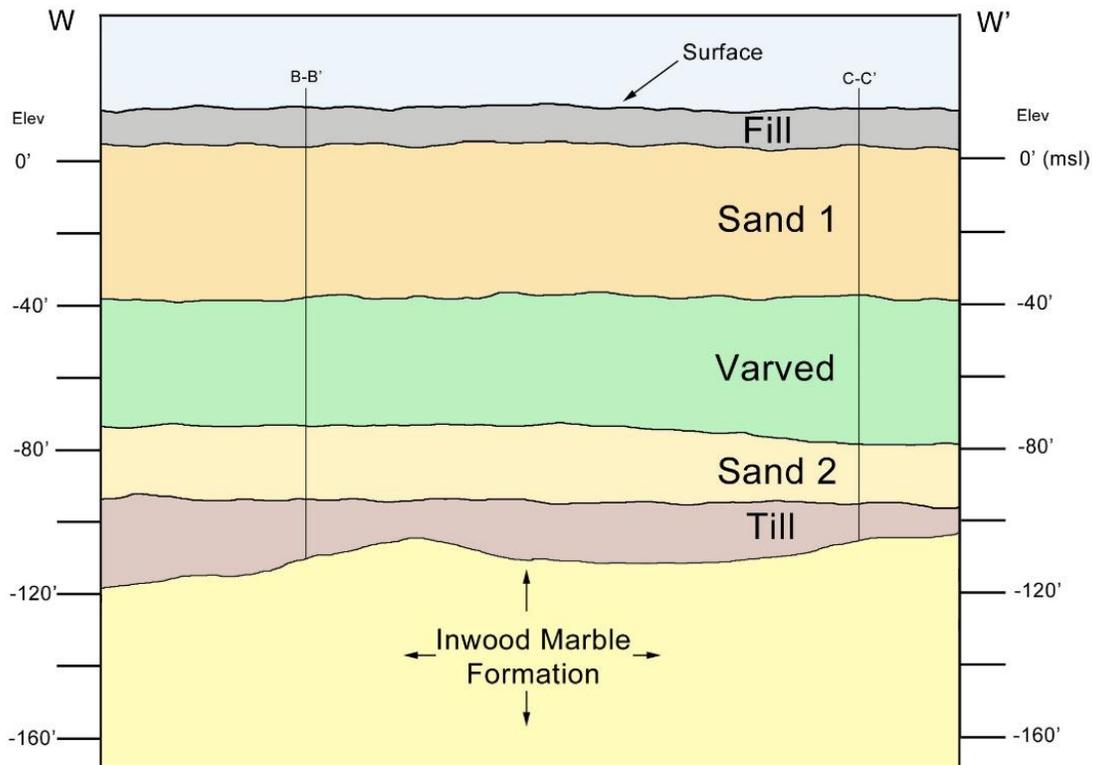
Figure 10 – Across site roughly W-E geological profile section drawn from data supplied in the geotechnical report showing overburden strata and the buried Inwood Marble bedrock layer. This view of the site was the anticipation and design criteria for the contractor's approved means and methods.

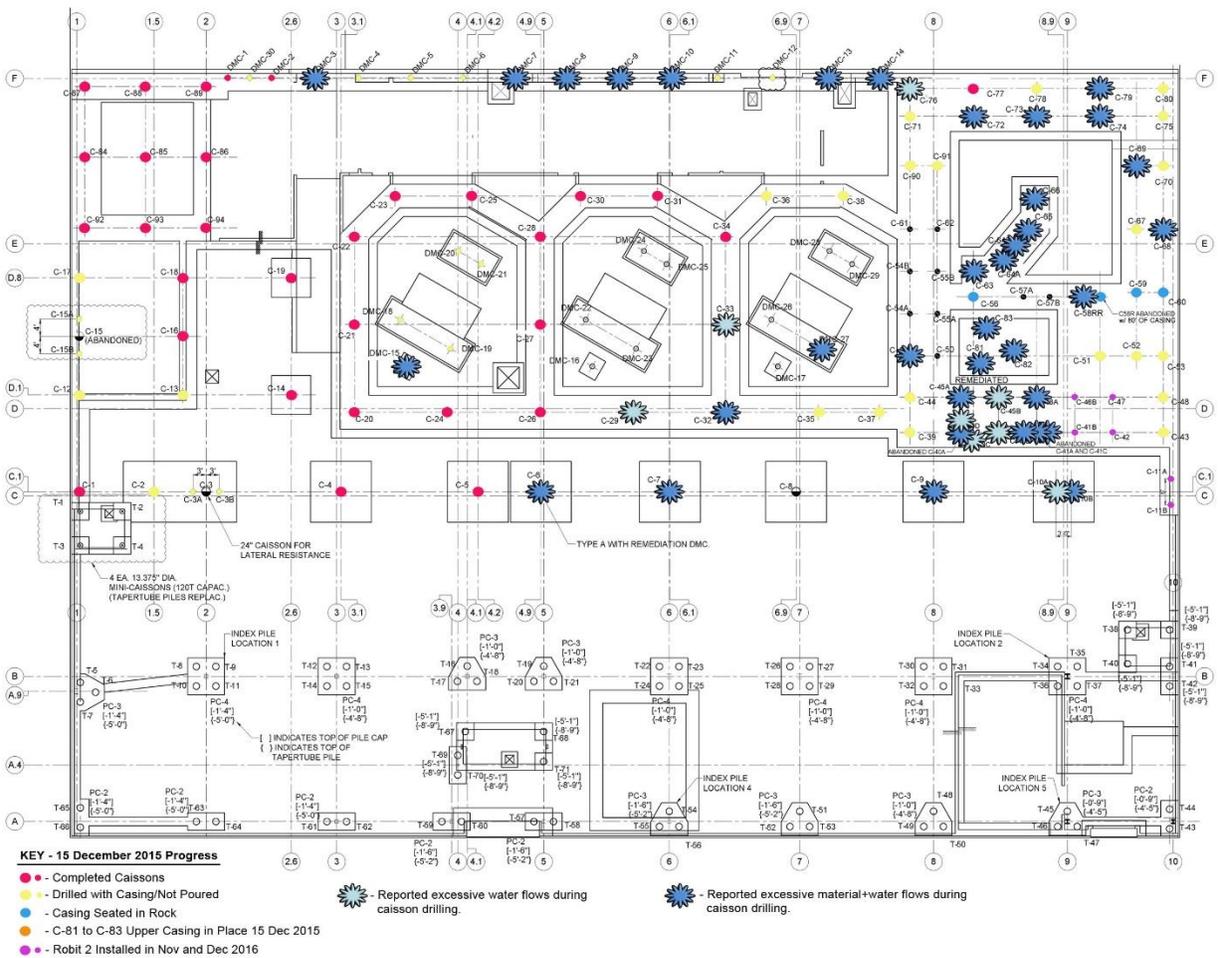
The problem caisson sites were not scattered throughout the site footprint which argued against any notion of improper means and methods (down-the-hole hammer systems) which were approved by the owners. Rather, the problem caissons were clustered in the northeastern corner of the site (Figure 11) where an adjacent, unsupported old-construction brick and mortar building settled, tilted, cracked and became severely damaged. What is more, water and material communication occurred between widely separated drilled caisson/pile sites indicating significant subsurface connectivity of transmissive features. Site reports by the contractors and the owner's resident engineers reported "heavy water, sand, and rock; excessive water from casing; thick (heavy) sediment inflows up to 25'; seams; rock ledges; dirty discharge; large rocks; sockets making water; communication between open drill sites; flooding of the jobsite; spoils on the ground; and equipment damage including broken shoes, rig tilting, hammer clogging and unanticipated hammer firing."

Figure 11 – Site plan showing the clustering of forty-four (44) caisson sites where installation was met with construction difficulties associated with flowing water only (light blue symbols) and water + material outflows (dark blue symbols). The remaining caisson sites shown in red, yellow, orange, black, noncolored and purple were drilled without difficulty. Project north to top of map.

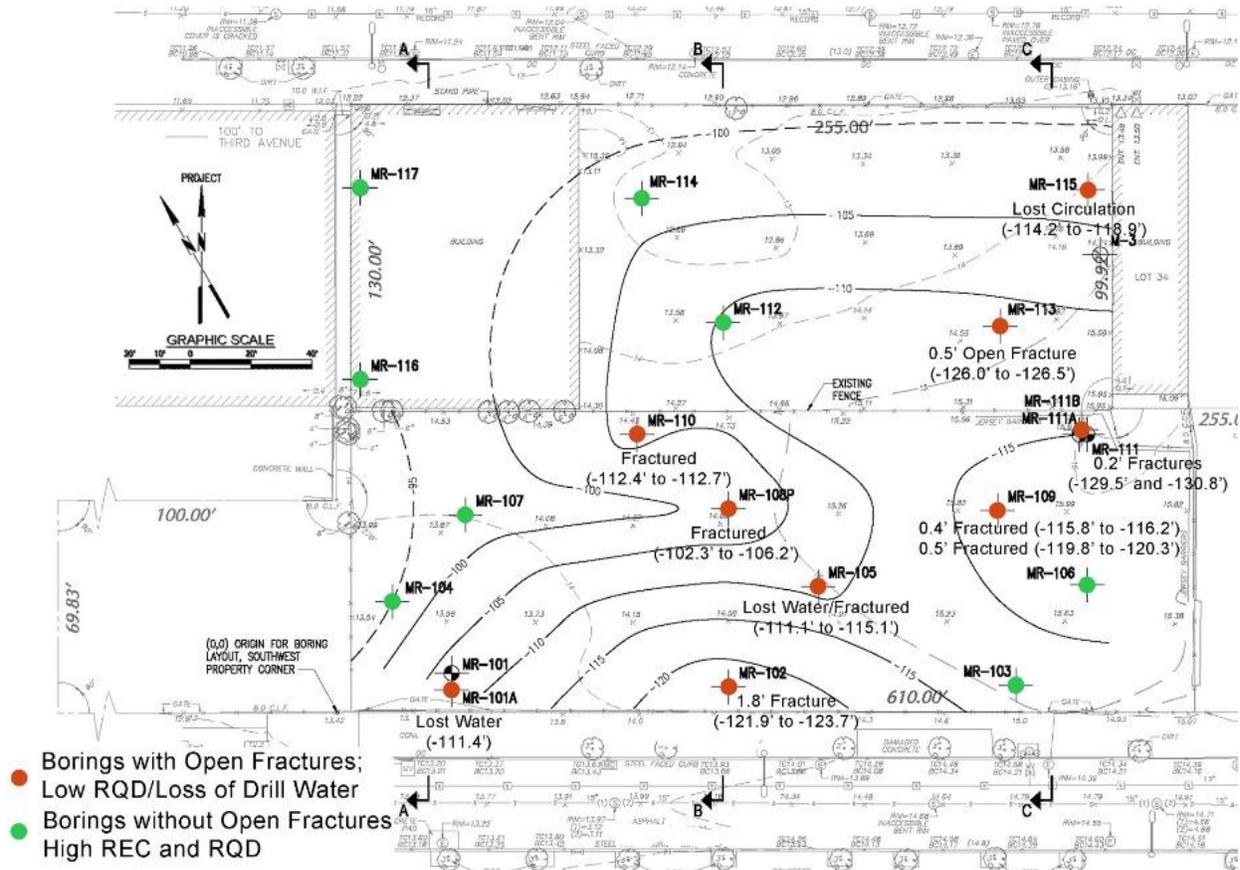
Figure 12 – Site plan map showing topographic data, annotated boring locations (MR-series) and top of rock contours within the footprint of the site. Nine borings with open fractures, low recovery and RQD values, and/or reported "loss of drill water" are shown in red. Eight competent borings without reported open fractures and with high recovery and RQD values are shown in green. Note the E-W clustered trend of the red borings.

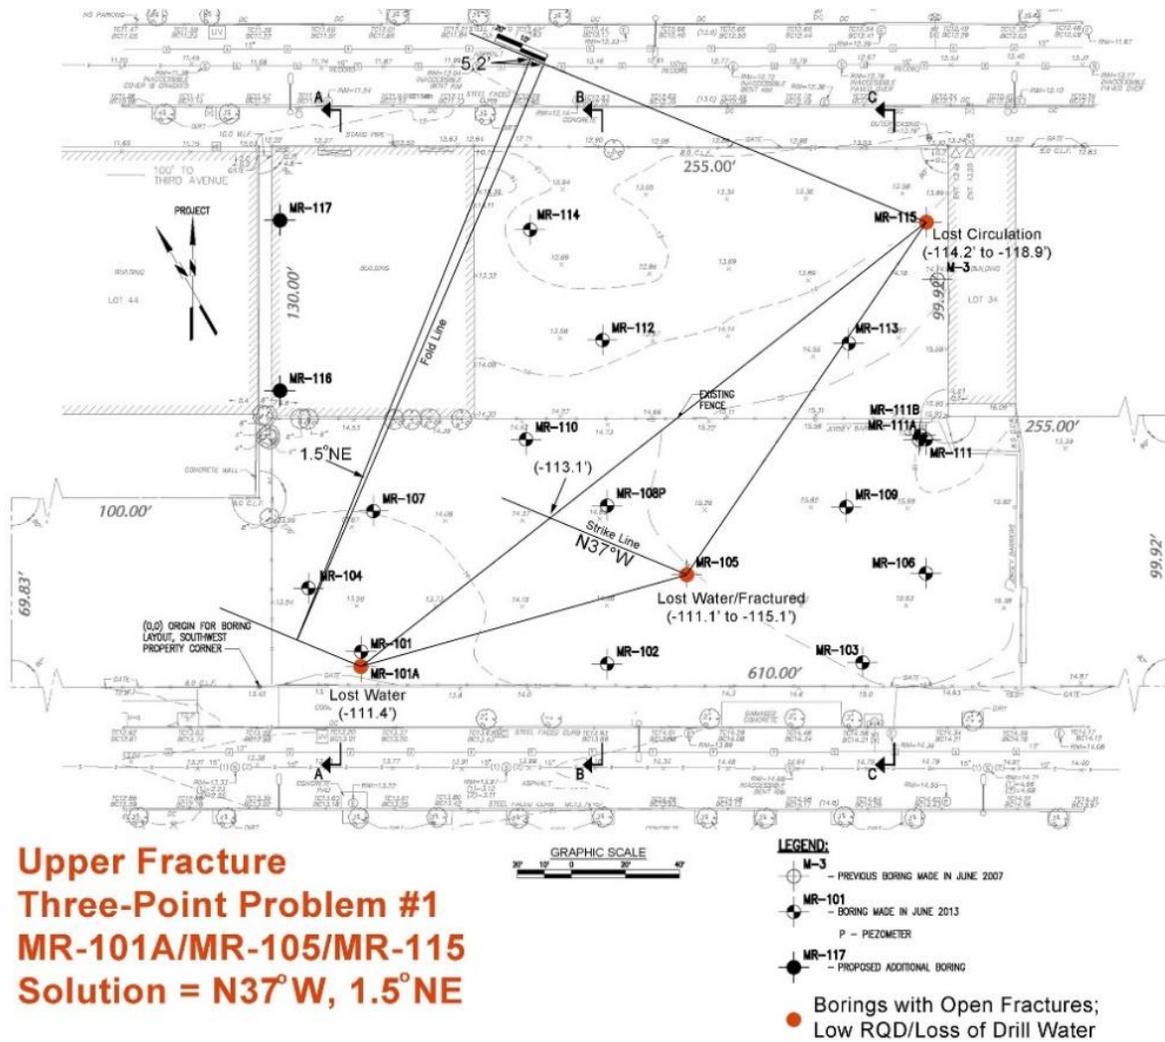
Figure 13 – Three-point solution #1 for upper fracture using data from borings MR-101A, MR-105, and MR-115.

Using the method described above the three-point problem solution #1) shows that three "loss of drill water" borings provided a solution that identifies an open fracture or fracture zone oriented N37°W, 1.5°NE. In order to test for and verify the lateral extent of the feature detected in Figure 13 we also grouped boring MR-101A, MR-105, and MR-115 as similar because of an RQD drop in Run 3C (64%) after much higher values in Runs 1C, 2C and 4C (REC and RQD % values both ranged from 95%-100% in these runs) and the presence of open (0.3') fractures. This allowed for two additional three-point solutions using MR-101A, MR-105, and MR-110 [Solution #2 = N12°E, 1°SE] and MR-105, MR-110, and MR-115 [Solution #3 = N3°W, 1.5°NE] (not shown here) which not only overlapped with Figure 13 result but yielded nearly identical strike and dip solutions.

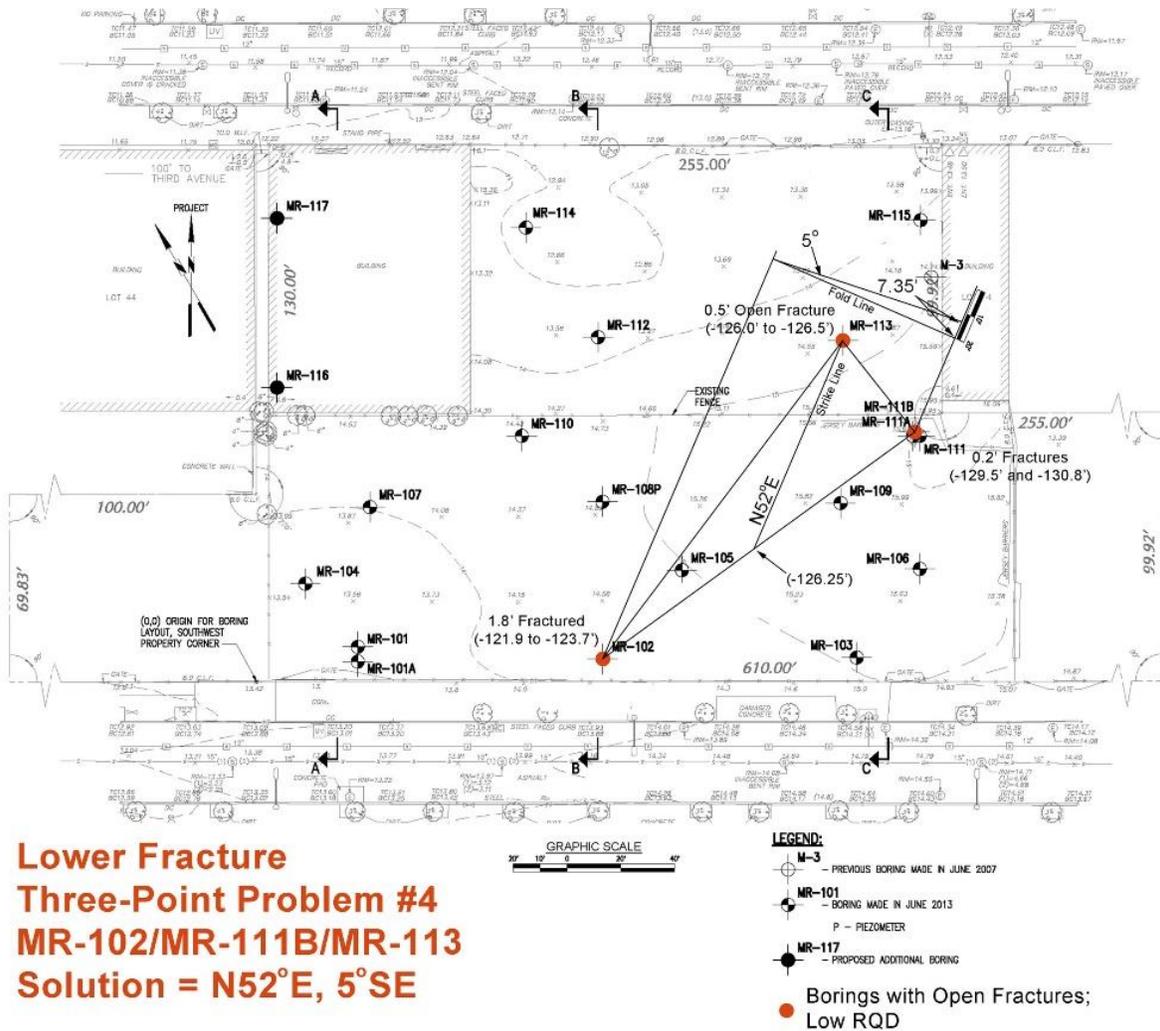
Borings MR-102, MR-111, and MR-113 show similar traits as those above in that they indicate a marked decrease of REC % and RQD % in lower core runs below a reach of competent rock. Using these data, three-point problem solution #4 shows a secondary deeper (lower) open fracture oriented N52°E and dipping 5°SE (Figure 14). The lower fracture is not as wide (0.2' to 1.8' wide) as the upper fracture and occurs 10' to 14' deeper than the upper fracture with slightly steeper dip.

Figure 14 – Three-point solution #4 for lower fracture using borings MR-102, MR-111B, and MR-113.

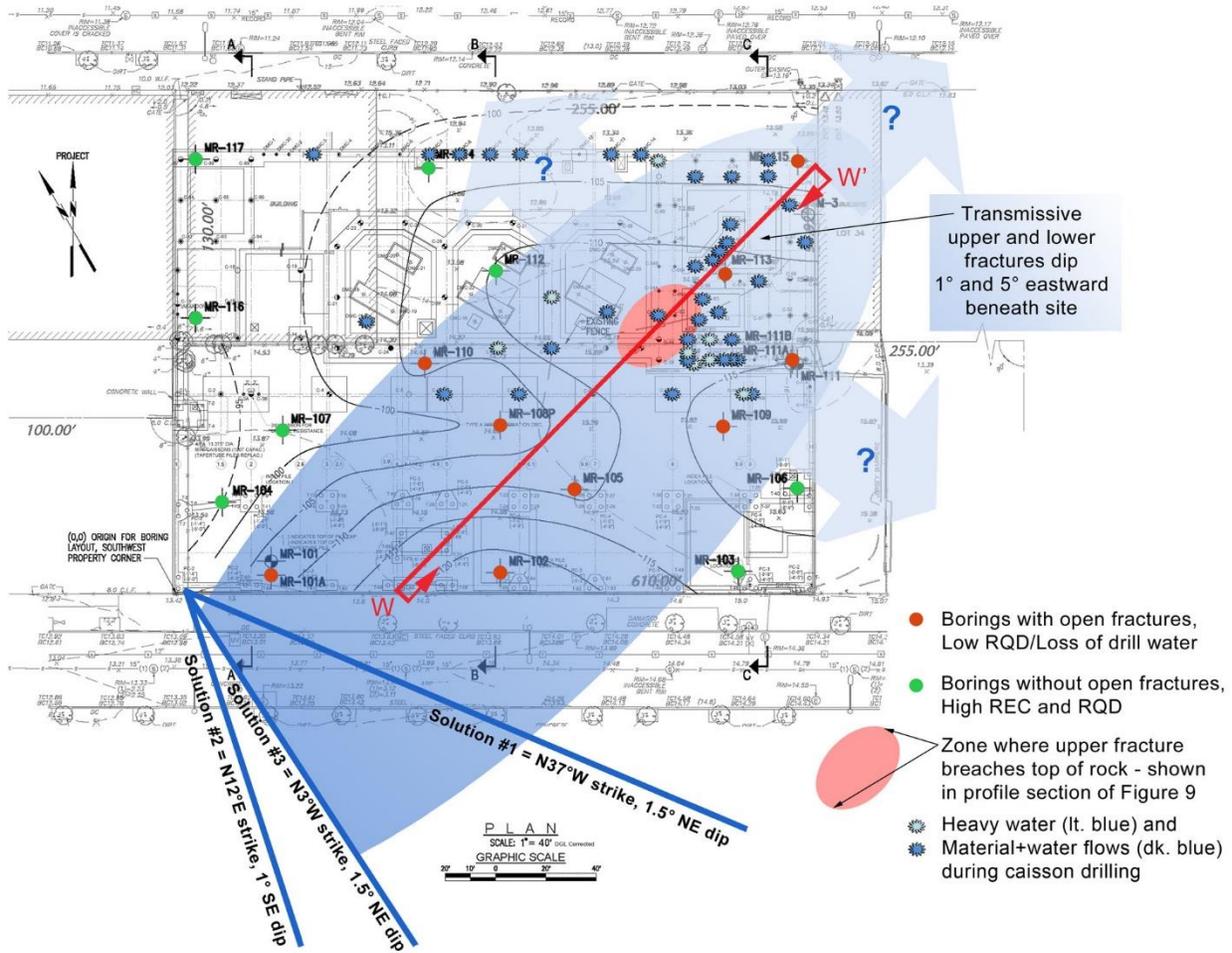
Two very gently inclined fracture zones descend below the top of rock at the job site based on the four fault plane solutions presented above. Figure 15 shows a conservative visualization of the east-dipping subsurface fracture system footprint (truncated blue ellipsoid) and shows a rather remarkable spatial coincidence with borings whose logs reported water loss during drilling and logs showing fractures below more competent rock. The extended blue arrows with blue question marks are a reminder that the fractures certainly extend for some distance along their strike and dip and may extend well beyond the zones shown in blue.

Figure 15 – Simplified plan map showing the three strike solution results of the three-point analyses presented in Figure 13 and 14 (dark blue lines) and two additional solutions not shown and borings harboring open fractures, low REC/RQD % and reported loss of drill water (red dots). Note the spatial coincidence of these borings with the projected footprint of the transmissive upper and lower fracture zones (eastward dipping blue ellipsoid) and their possible extensions down-dip and along strike (extended blue arrows). Also projected upward into plan view is the breached zone shown below in Figure 16 where the upper fracture zone is at or near the top of rock (pink ellipse).

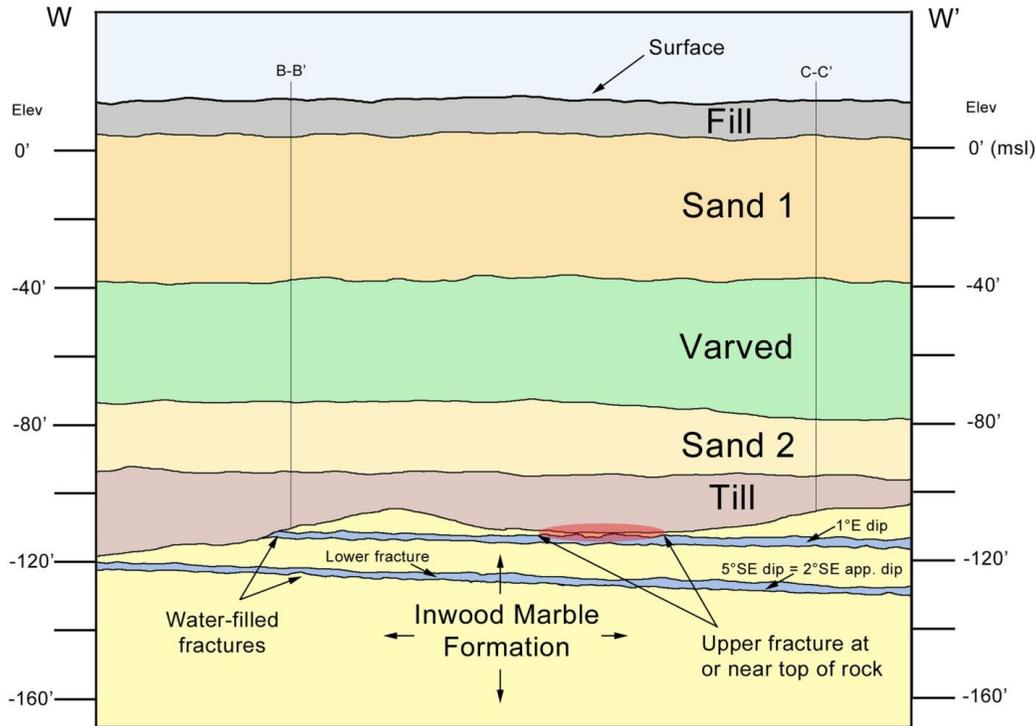
The profile section of Figure 16 shows that the upper fracture zone intercepts the buried top of rock near borings MR-101A and MR-102. It intercepts and connects directly with the till unit of the regolith. Here, at the western corner of the site where top of rock slopes down, the lower fracture will also intercept the top of rock, but off-site.

Thus, **both fracture zones** intercept the top of rock and connect to water-saturated regolith toward the west and as such provides a conduit for significant lateral flow of groundwater and sediment within the bedrock. Based on the data near MR-111B and MR-113, the upper fracture zone is at or near the fractured top of rock as shown diagrammatically by the pink elliptical zone in both map and profile section. (Compare Figures 15 and 16.) This hydrologic connection, even without any steep fractures, creates a unique plumbing system

Figure 16 – Roughly west to east profile section (W-W’) keyed to Figure 15 showing overburden strata and Inwood Marble bedrock containing water-filled fracture zones (blue) detected beneath site using three-point problem solutions. Section is drawn roughly perpendicular to N-S strike of bedrock fractures. Water-filled transmissive bedrock fractures from three-point solutions are based on my interpretation of data from boring logs and by using the top of rock contour map and geological sections provided by the pre-bid geotechnical report for control. Note the unique bedrock to overburden plumbing system provided by the open-aperture subsurface fracture zones that intercept the top of rock in a few places. (Drafted without vertical exaggeration.)

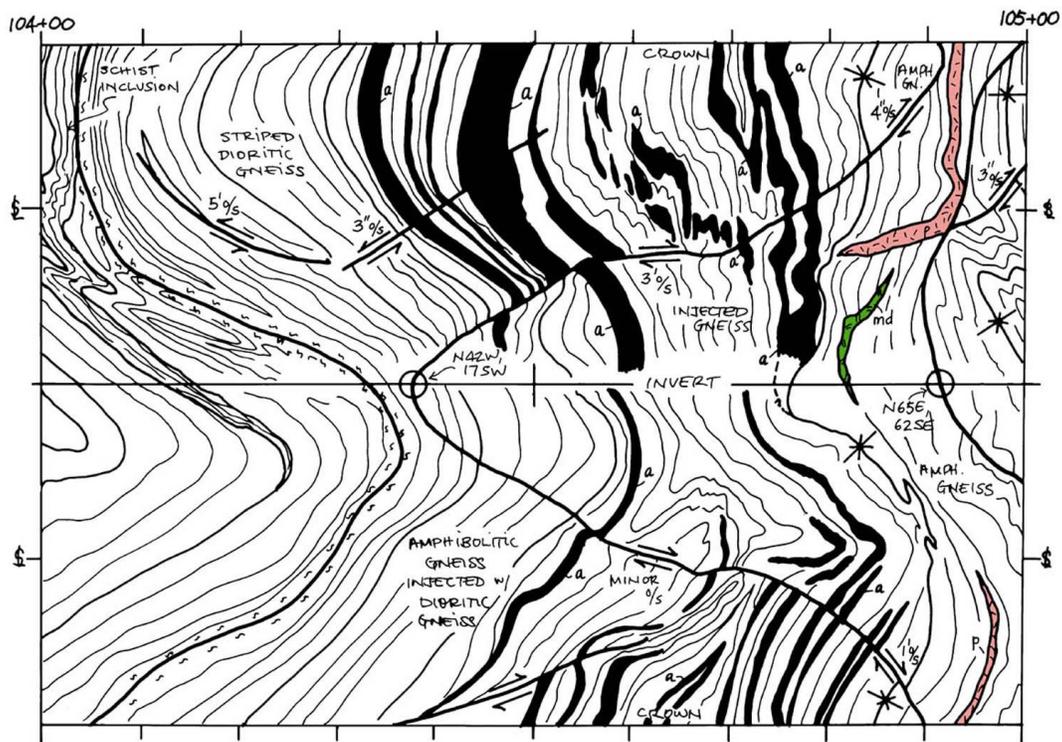
Figure 19 – Geological map of Tunnel #1 shows granulite-facies amphibolite gneiss and younger dioritic orthogneiss cut by pegmatite (p) and a mafic dike (md). The amphibolitic gneiss is locally sheared but clearly occurs as inclusions in the dioritic gneiss. The tunnel invert is shown along the center of the map and the tunnel walls curl upward into a cylinder to join at the crown. The position of the tunnel springline is shown at the map edge. This map, one of 250 in the unpublished Tunnel #1 Map Portfolio, records 100' of the tunnel. A low-angle reverse fault oriented N42°W, 17°SW cuts the invert at Station 104+38 (tunnel invert bearing is N22°E). A younger N65°E, 62°NE brittle fault cuts the invert at Station 104+91. Original map scale 1" = 10'; tunnel diameter 23' 2".

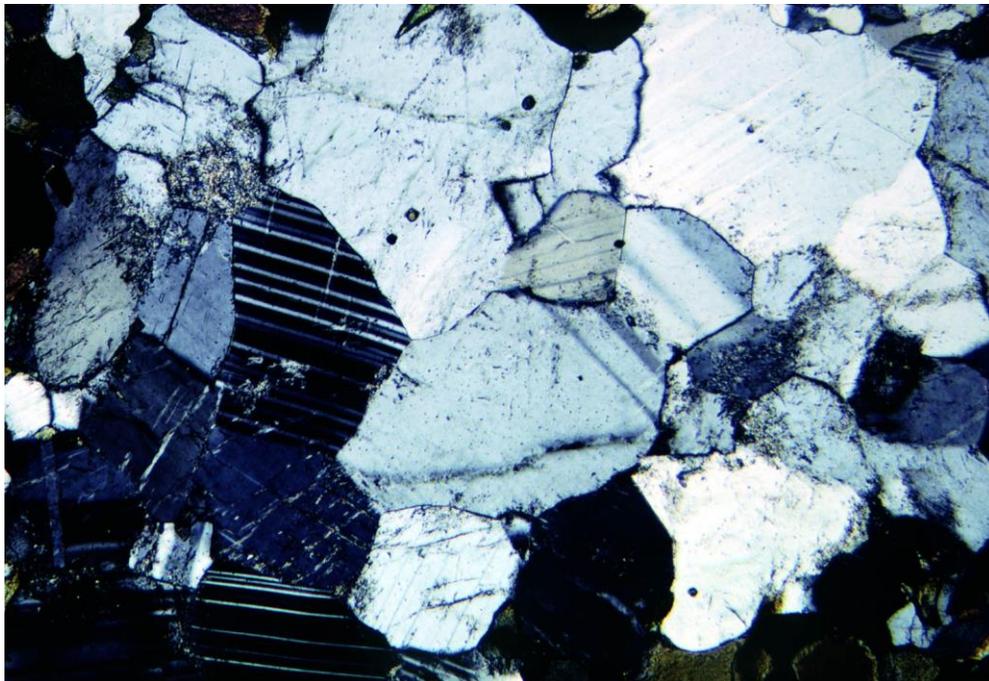
Compare the rock textures shown below between foliated rocks of the anticipated Hartland Formation (Figure 23A) and a leucocratic orthogneiss found in Tunnel #1 (Figure 23B). Proper petrographic analysis would have alerted bidders to this lithologic departure from pre-bid anticipation but sadly, little competent petrographic work was conducted pre-bid on this job.

Figure 23B – Photomicrograph in crossed nicols of Tunnel #1 leucocratic orthogneiss (Sample Q085; Station 159+80) showing granoblastic intergrowth of plagioclase and minor quartz. Note the granular texture, the stable 120° grain boundaries of the interlocking plagioclase, and the lack of any penetrative foliation. Both photomicrographs of Figure 23 are 2 mm across.

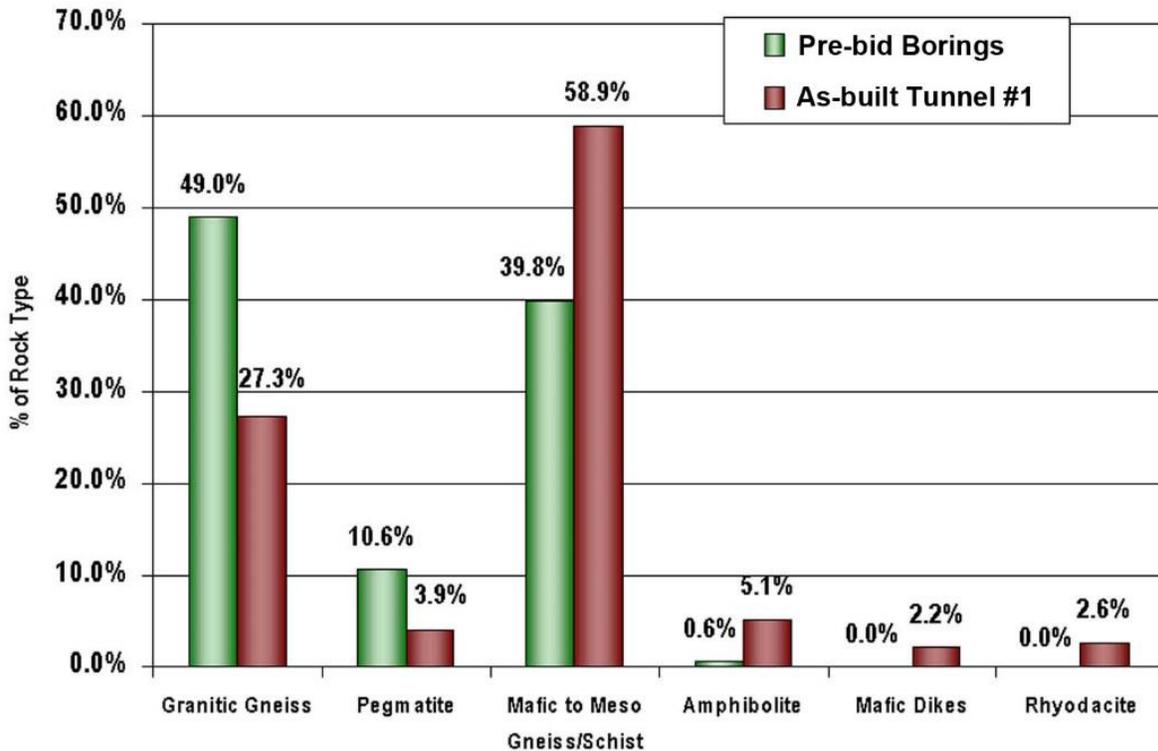
Figure 24 - Comparative bar graph showing the disparity between lithotypes identified by examining pre-bid borings (green) vs. those found to occur in a tunnel horizon by as-built mapping (red). Note the difference in the relative proportion of granitic and pegmatitic (felsic) rocks vs. the mafic, amphibolitic, and mesocratic (mafic and intermediate) rocks and the presence of unanticipated rocks of rhyodacite affinity. This compositional variation from pre-bid anticipation proved an impediment to efficient mining. (Adapted from Merguerian and Ozdemir, 2003.)

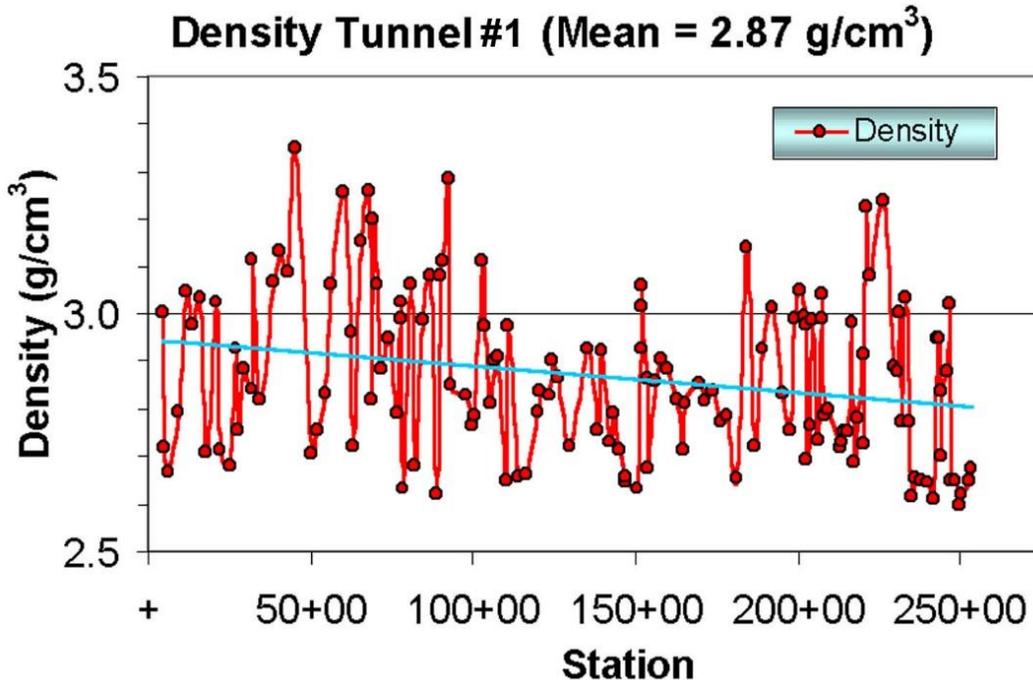
Figure 25 – Rock mass density variation as compiled from sawn slabs from 161 samples collected during as-built mapping of Tunnel #1, NYC. The graph indicates that the bulk density of the tunnel varied from 2.62 to 3.35 gm/cm³ and that density decreased slightly toward the higher stations (sloping blue line) as shown by the mapping. The mean density (2.87 g/cm³) was in keeping with the lithotype analysis (See Figure 24.) that indicated that more intermediate- to mafic lithologies were penetrated in the tunnel by comparison to what the pre-bid borings indicated. Typical schist and granofels which constitutes the Hartland Formation should have averaged about 2.55 g/cm³. (Adapted from Merguerian and Ozdemir 2003.)

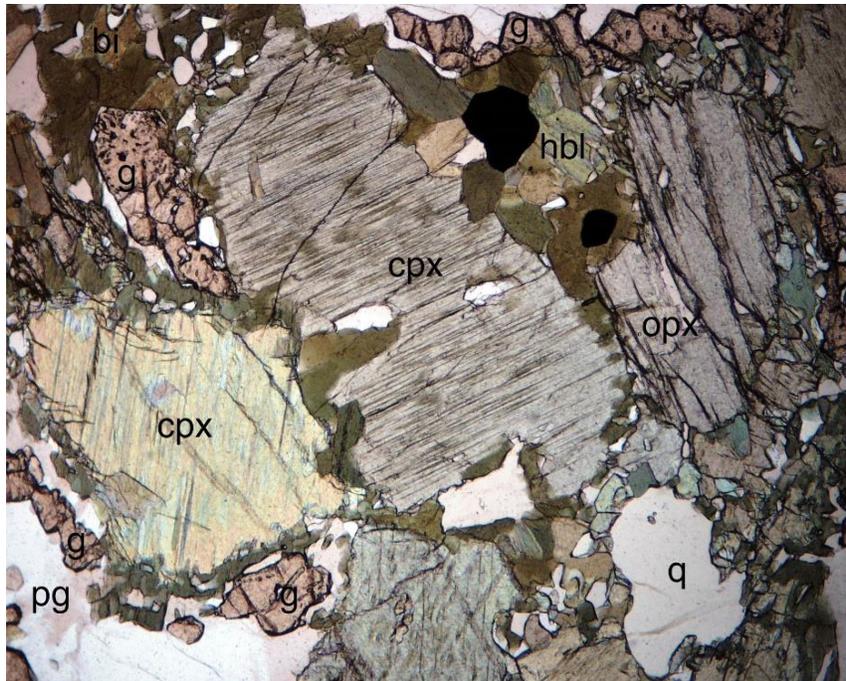
Lacking a penetrative foliation, the coarse-textured granoblastic rock texture and extraordinary garnet content of up to 50% in some zones that underlie ~11% of the entire tunnel (Figures 27A, B; Table 1) together proved an impediment to efficient TBM chip production and resulted in bimodal production of rock powder (excessive fines) and large blocks that choked TBM grizzlies and damaged outgoing conveyor belt systems (Merguerian and Ozdemir 2003).

Figure 26A – Photomicrograph in plane-polarized light of Tunnel #1 mafic gneiss showing coarse-textured granulite facies texture in the form of partly recrystallized orthopyroxene (opx), clinopyroxene (cpx), and primary garnet (g). Quartz = q. Note the thin overgrowths of hornblende (hbl), granular garnet (g) and biotite (bi), the result of secondary metamorphic recrystallization. (Sample Q114; Station 15+90; 2 mm field of view.)

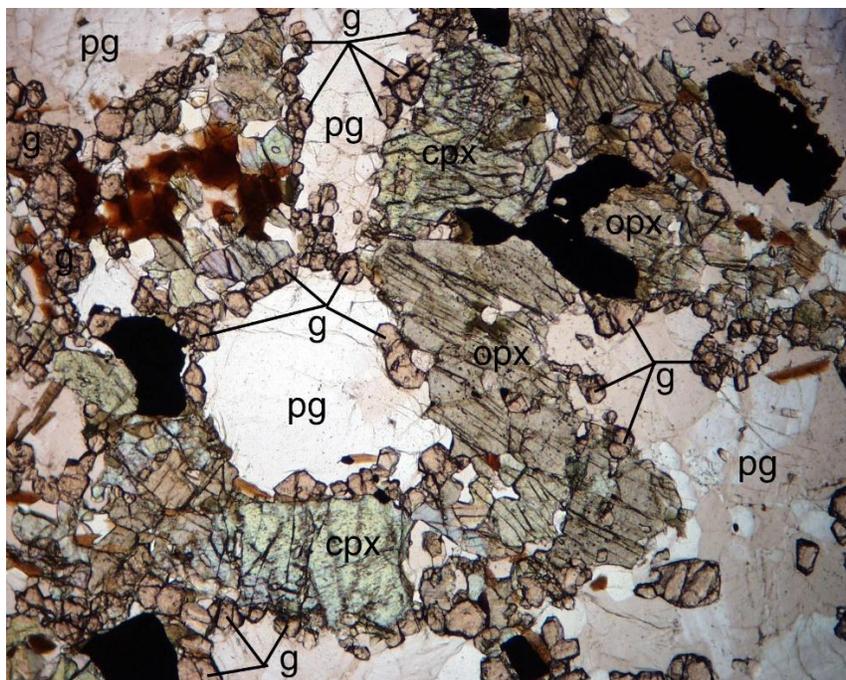
Figure 26B – Photomicrograph in plane-polarized light of mesocratic gneiss showing “garnet necklace” structure. Note the semi-circular patches of high relief garnet. This replacement texture results from the production of garnet and hornblende reactions rims adjacent to primary coarse-textured orthopyroxene, clinopyroxene, and plagioclase during secondary metamorphism. Same notation as above. (Sample Q146; Station 80+64; 2 mm field of view.)
