Geological Solutions for Providing a Scientific Basis for Differing Site Condition Claims

Charles Merguerian, Duke Geological Laboratory, 55 Spongia Road, Stone Ridge, NY 12484, (845) 687-6386; CharlesM@Dukelabs.com

Abstract

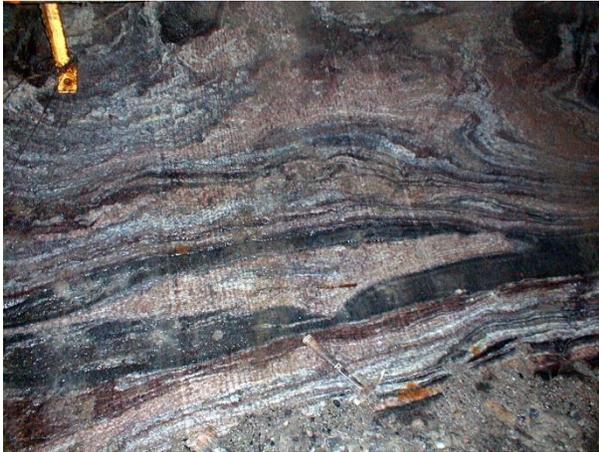
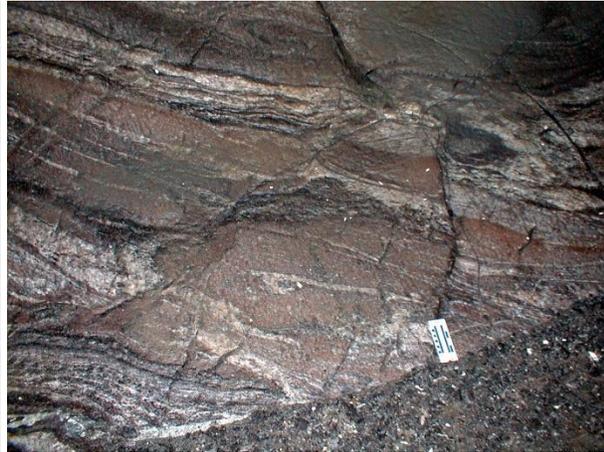
Figures 27A, B – Views of two of the 32 garnet zones mapped in Tunnel #1 showing the anomalously high concentration (up to 50%) of dense garnet that defines such zones. Highlighted in yellow on Table 1 (below) the garnet zones 9 (A.) and 21 (B.) were produced during phases of granulite- followed by upper-amphibolite facies metamorphism as detected in the petrographic analysis of mineralogy and rock mass textures.
