Geological Solutions for Providing a Scientific Basis for Differing Site Condition Claims

Charles Merguerian, Duke Geological Laboratory, 55 Spongia Road, Stone Ridge, NY 12484, (845) 687-6386; CharlesM@Dukelabs.com

Abstract

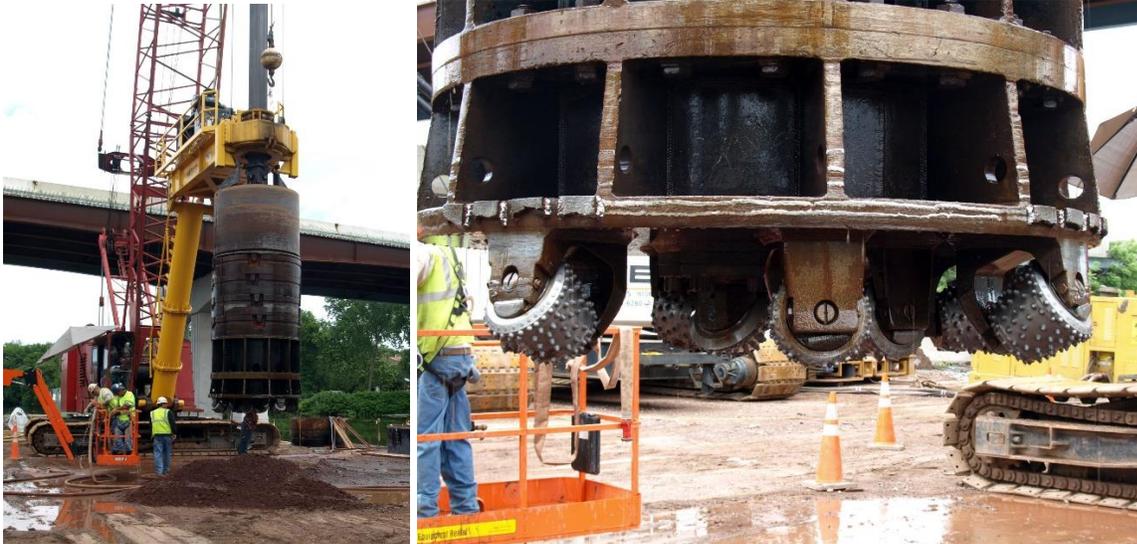
During construction of the bridge, 45 shafts of 96” diameter were drilled for bridge piers using identical means and methods and finished with 90” rock sockets. Difficulties in construction were encountered in drilling eight of the river shafts. In these instances, shaft construction was hindered by voids, high-water inflows and in-falling blocks of red-colored siltstone and sandstone. The ground conditions required remediation including grouting, additional drilling, reseating of casings and deepening of shafts. A view of the equipment used for subaqueous drilling is shown below (Figure 2).

Figure 2 – Westward view of Shaft #23 construction rig near Pier 3 of job site in New Jersey (L) and close-up view of the cutterhead and cutters (R) designed for sedimentary rocks. (Dukelabs digital images taken 14 June 2013.)

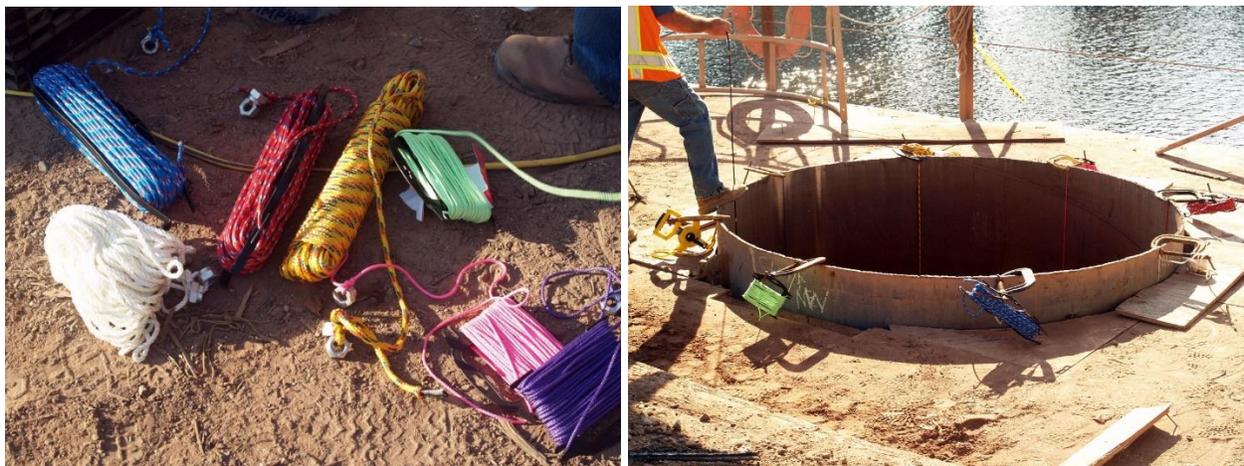
In order to calibrate and map the shaft interior we marked the walls by suspending weighted colored ropes with magnetic N, E, S, and W and intervening magnetic compass directions NE, SE, SW, NW so that calibration, recording and calculating the orientation of geological features could be accomplished (Figure 5).

Figure 5 – Various ropes used with weights and C-clamps to hold ropes taut and vertical down the sides of the shaft in order to video each compass rose direction with depth calibration. Analysis of the color-coded videos allowed us to generate an accurate flat 2-D map of the interior of the rock socket.

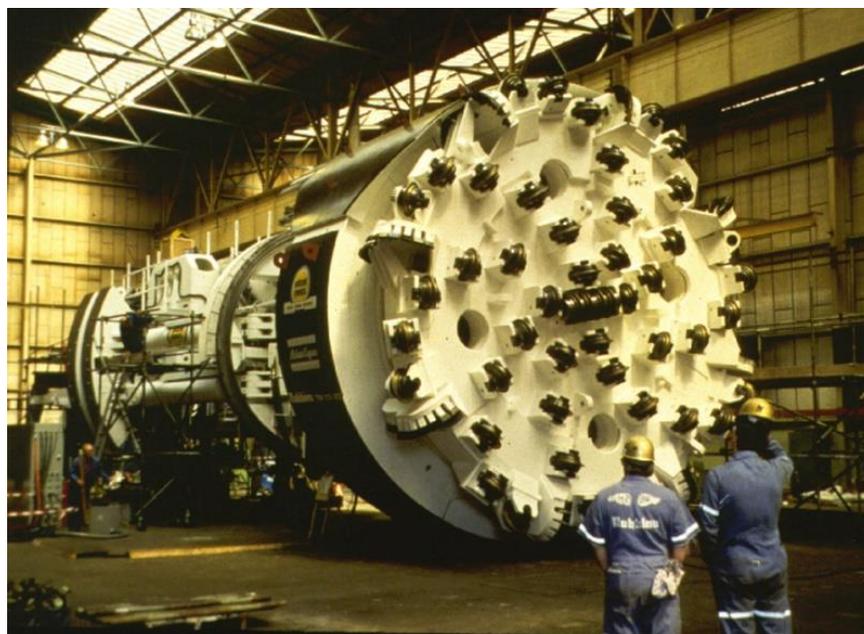
The main issues encountered on this job were much lower than anticipated TBM advance rates, side-wall and crown instability, invert heave, short-stand up times and resulting missed construction deadlines and lost production costs. The main culprits in this case were the Geotechnical Baseline Report (GBR), a contract document which identified the wrong NYC rock formation (Hartland Formation) with rock mass properties vastly different from that which was encountered and a pre-bid drilling program that was too widely spaced and under-analyzed. This consulting engagement required a number of parallel geological efforts rooted in detailed mapping of the entire tunnel, petrographic analysis of collected rock specimens, rock mass statistical analysis which included lithotypes, mineralogical and density studies, geochemical and geochronologic analysis, characterization of zones of geological anomalies and comparisons of decreased advance rates and utilization to geology and as-built TBM performance data (Merguerian and Ozdemir 2003).

Figure 17 – View of front 84’ of the roughly 300’ long Robbins single-beam hard rock TBM (Model 235-282) which was assembled in bellout at base of main access shaft of Tunnel #1.

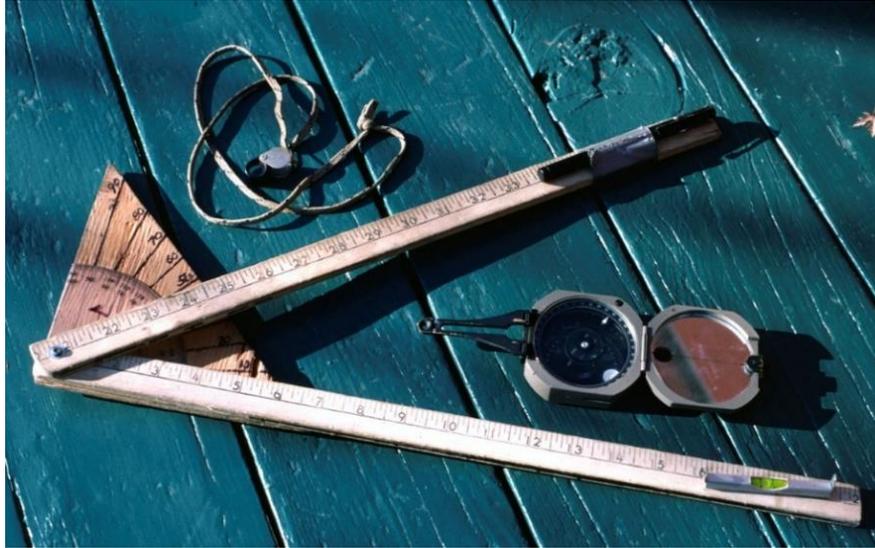
The presence of iron in the service locomotive tracks, metal piping, ductwork, and the conveyor system precluded the use of a Brunton compass for standard strike-and-dip measurements. After discussions with our dear friend Scotty (Geologist, NYC DEP), we constructed a laser-pointer leveling device that was able to accurately measure the strike of features with respect to the surveyed tunnel trend (Figure 18). By climbing up on the piping of the tunnel wall and having a clear view of the other wall, features such as faults, foliation, and dikes were relatively easy to view and trace across the crown using this device. A bubble level was used to hold horizontal both ruler sections on the feature to be measured and laser pointer was used to sight the same feature on the other wall. In this way one could measure the angle made between the strike of the feature with respect to the surveyed tunnel invert centerline trend.

Figure 18 – In-house mechanism used for measuring strike of features exposed on both tunnel walls at springline and comparing to surveyed invert orientation. Dips were measured using Brunton compass and verified by standard cartographical calculations from map geometries.

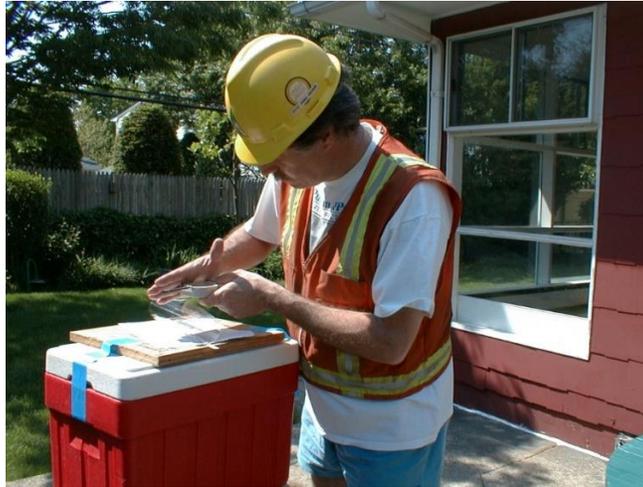
Internal rock fabrics (gneissic layering) and faults were remeasured using oriented rolled mylars of the individual maps utilizing a Brunton compass as shown in Figure 20. Such measurements disclosed that the gneissic fabric of Tunnel #1 was not in a favorable orientation for efficient TBM mining. Although the pre-bid data indicated a NE-trending steep-SE dipping rock foliations our stereonet analysis of the as-built gneissic layering between Stations 4+00 and 254+00 demonstrated that 26 of 235 poles (11%) indicated subhorizontal layering (Figure 21). Overall 64 poles (27%) showed gentle dips of less than 30°. Thus, subhorizontal to gently dipping rock fabrics underlie broad tracts (38%) of Tunnel #1. The structural grain of Tunnel #1 presented an unfavorable rock fabric orientation for productive TBM mining.

Figure 20 – Strike and dip of planar features were remeasured by sighting and compared to tunnel measurements from rolled map mylars aligned with respect to true north using a Brunton compass outdoors. Liquid refreshments stored in the cooler were enjoyed after the measurements were made, compared to map data and recorded.

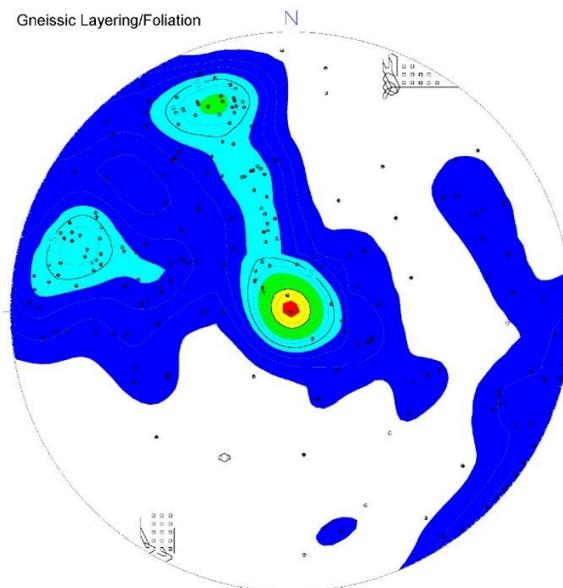
Figure 21 – Subhorizontal clustering of stereonet poles (27%) together with anticipated NNE- and ENE-strike and steep SE dips of gneissic layering/foliation (n = 254).

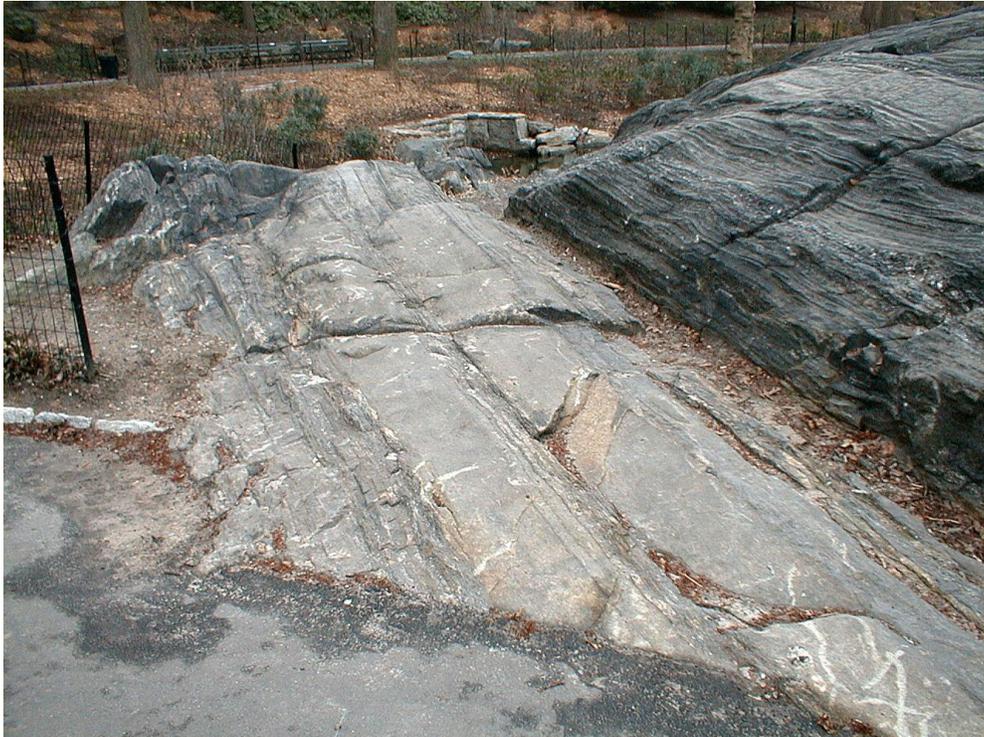
Petrographic Analysis. Petrography is one of the basic tools used extensively in geological analysis of crystalline rocks as it allows for identification of minerals, mineral crystal textures and metamorphic paragenesis. The process involves collection of rock samples or pieces of rock core and precise preparation of petrographic slides. The slides are 30-micron thick slices of rock sandwiched between two pieces of glass (base slide and a thinner cover slip) which together form a rock “windowpane” held together by epoxy of known optical index. In conjunction with geological mapping, metamorphic rocks reveal their structural and metamorphic history and in the case of Tunnel #1, proved that the rocks were not schist or granofels of the Hartland Formation (Figure 22).

Figure 22 – View of typical interlayered Hartland schist and granofels from an exposure at the SE part of Central Park in New York City. (Digital image taken 04 April 2003.)

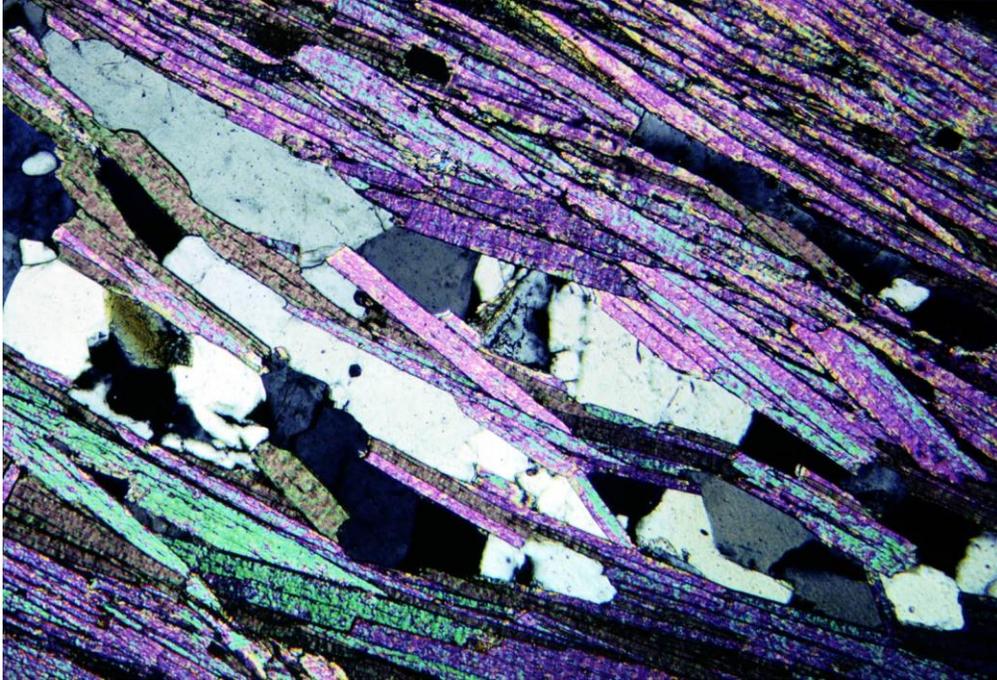
Compare the rock textures shown below between foliated rocks of the anticipated Hartland Formation (Figure 23A) and a leucocratic orthogneiss found in Tunnel #1 (Figure 23B). Proper petrographic analysis would have alerted bidders to this lithologic departure from pre-bid anticipation but sadly, little competent petrographic work was conducted pre-bid on this job.

Figure 23A – Photomicrograph in crossed nicols of aluminous Hartland schist (Sample N403-1; World Financial Center site, lower Manhattan). The section shows fine-textured lenticular quartz and minor plagioclase separated by aligned muscovite and minor biotite (highly colored crystals). Such directional mineral growth results in a penetrative micaceous foliation that splits readily because of the parallelism of relatively soft mica flakes.
